# Environmental monitoring of the archaeological deposits at Øvregaten 19, Bergen

## Concluding report 2013-2017

NIBIO RAPPORT | VOL. 3 | NR. 101 | 2017

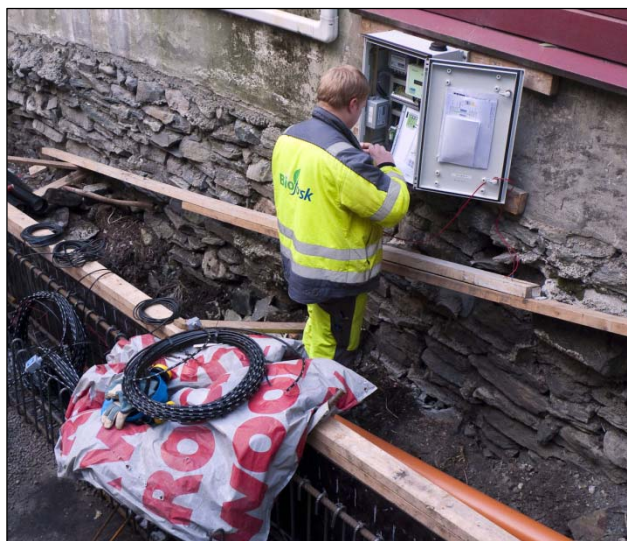
Figure 2. A waterproof cabinet for the automatic logger from SEBA Hydrometrie GmbH was installed on the wall close to the site.

The sensors that have been installed are TRIME-PICO 32 from IMKO Modultechnik GmbH. These sensors can be installed in a heterogeneous and sandy stone-rich type of soil that is often found at archaeological sites. The sensors have universal calibration for mineral soils as standard. All sensors were connected to an automatic standard logger from SEBA Hydrometrie GmbH (<http://www.seba-hydrometrie.de/en/applications.html>). The data is made accessible on a website via mobile modem technology. The logger and battery were placed in a waterproof cabinet close to the site (Figure 2).

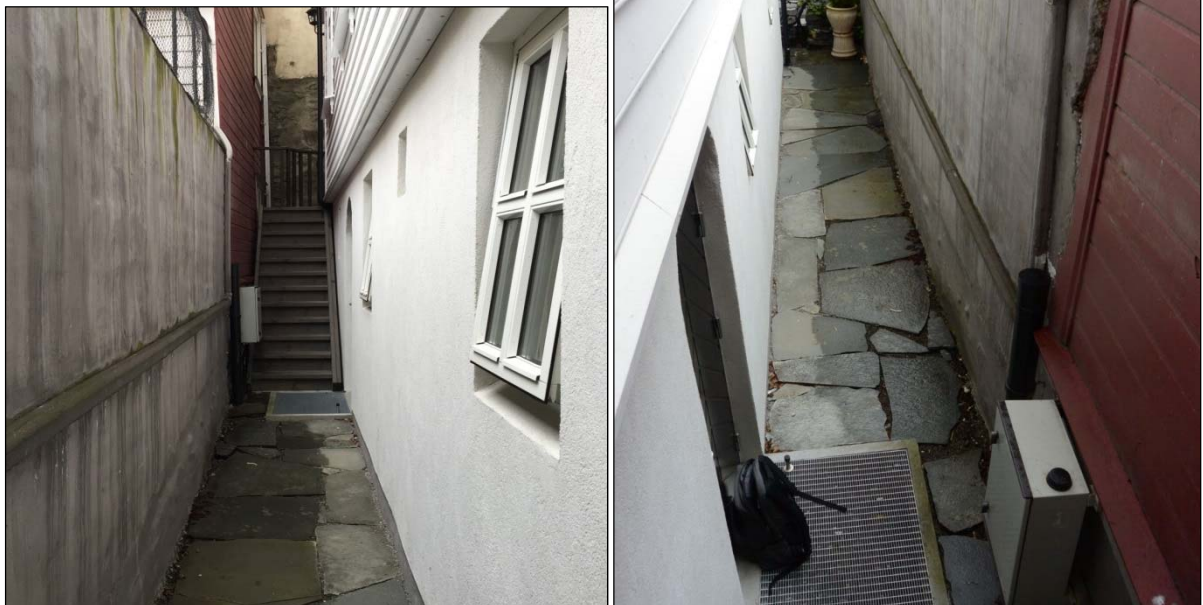
*Location of Cabinet with the logger at Øvregaten 19 (June 2016)*

Sensors and logger were checked in June 2015.

The logger battery was recharged in late June 2015.

The battery capacity for the monitoring equipment is still satisfactory and is expected to work well for the rest of the monitoring period.
